The Public Inquiry into the Piper Alpha Disaster

The Hon Lord Cullen

VOLUME ONE

Presented to Parliament
by the Secretary of State for Energy
by Command of Her Majesty
November 1990

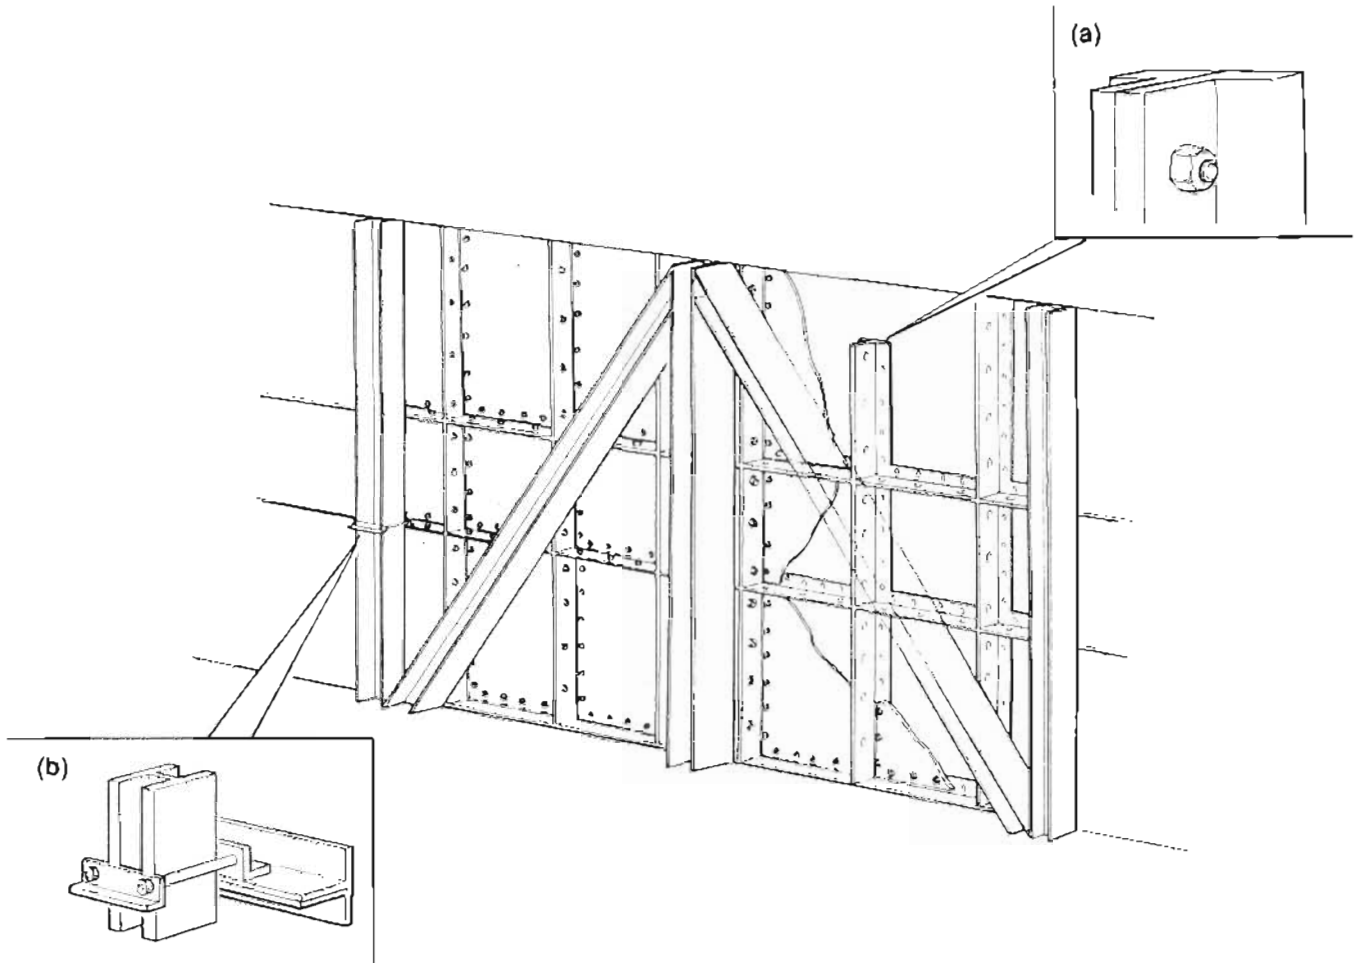
5.100 The B/C firewall was a single-layer 4.5 hour integrity wall. It consisted of an array of rectangular panels, bolted into rectangular frames, with adjacent frames bolted together, forming a 'lattice'. The lower edge of the wall was welded to the production deck and its top edge attached to the underside of the upper truss beam by an arrangement of bolted and welded joints. The wall was further supported by clamping to the truss columns. The firewall is illustrated in Fig 5.2; the figure is schematic and is not to a consistent scale. The view seen in the figure is that seen from the inside of C Module looking south. In the analysis of failure of the single-layer firewall the following failure modes were considered: panels, panel bolts, lattice framework, frame bolts, clamps and welds to the deck and to the truss. Dr Cox summarised the analysis as follows. The capacities of both panel and frame bolts would be exceeded at a pressure of about 0.1 barg. Of the 2, the frame bolts were more critical in that failure of these would lead to failure of the lattice. Failure of the clamps would occur at about 0.12 barg and of the panels themselves at about 0.15 barg. In effect, the firewall would disintegrate at over-pressures somewhere in the region of 0.1-0.15 barg. He took the effective failure pressure of the single-layer firewall as 0.1 barg. The behaviour of the single-layer firewall in failure would be as follows. At pressures below about 0.1 barg the panels would start to deflect; at about this pressure frame and panel bolts would start to fail; at pressures above it frames would start to separate and, where the lattice was still intact, panels would start to collapse, whilst the clamps holding the whole wall might start to fail.

Fig. 5.2 Schematic of single-layer firewall between B and C Modules: insert (a) frame bolt; insert (b) clamps.

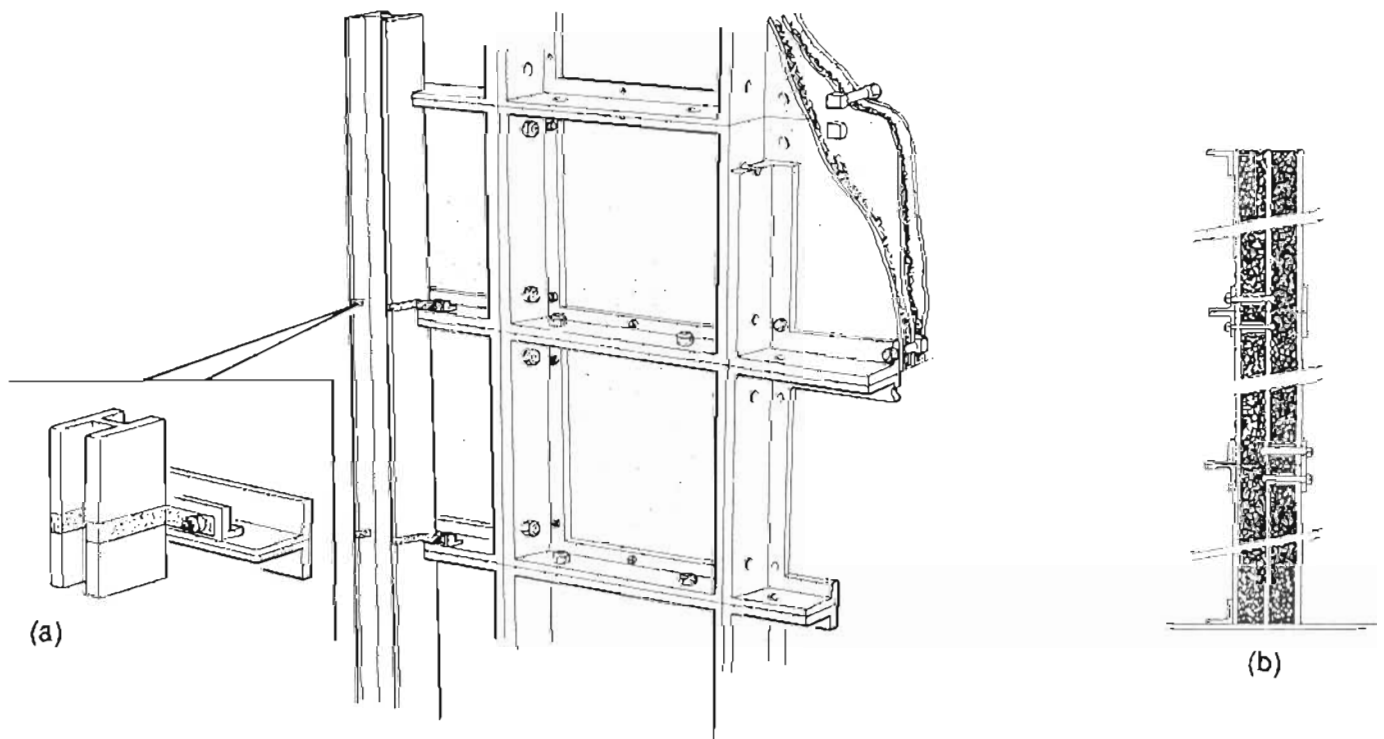
5.101 The C/D firewall was a triple-layer 6 hour integrity wall. This wall also differed from the single-layer wall in that the panels were of different size; the frames were smaller, being 7 rather than 3 frames high; there was a complex offset bolting arrangement; the arrangement of the panel and frame bolts was different in detail; and the clamping arrangements were different. The firewall is illustrated in Fig 5.3; the figure is again schematic but in this case the panelling is on the remote side of the lattice. The view in the figure is that seen from the inside of D Module looking south. An analysis similar to that on the single-layer firewall was performed on the triple-layer firewall. Again the frame bolts were the weakest component. Failure of these bolts was predicted to occur at a pressure of 0.12 barg. Failure of the panel bolts in

Fig. 5.3 Schematic of triple-layer firewall between C and D Modules: insert (a) clamps; insert (b) cross-section through fire wall, showing three sheets with mineral wool between.

shear loading or tearing of the panel would occur at about the same pressure. The outer sheet of the panels, supported only by very narrow bolts, would also start to fail at about 0.12 barg. However, the inner sheet, being more strongly supported, would not fail until a pressure of about 0.36 barg. This is a higher pressure than the failure pressure of the panels of the single-layer firewall because the panels of the latter are larger. Dr Cox took the effective failure pressure of the triple-layer firewall as 0.12 barg. As far as concerns the failure behaviour of the triple-layer firewall, at pressures below about 0.12 barg the panels would start to deflect; at about this pressure frame and panel bolts would start to fail and panels to tear; at pressures above it frames would start to separate and panels to separate from the frames but not to push through until higher pressures are reached.

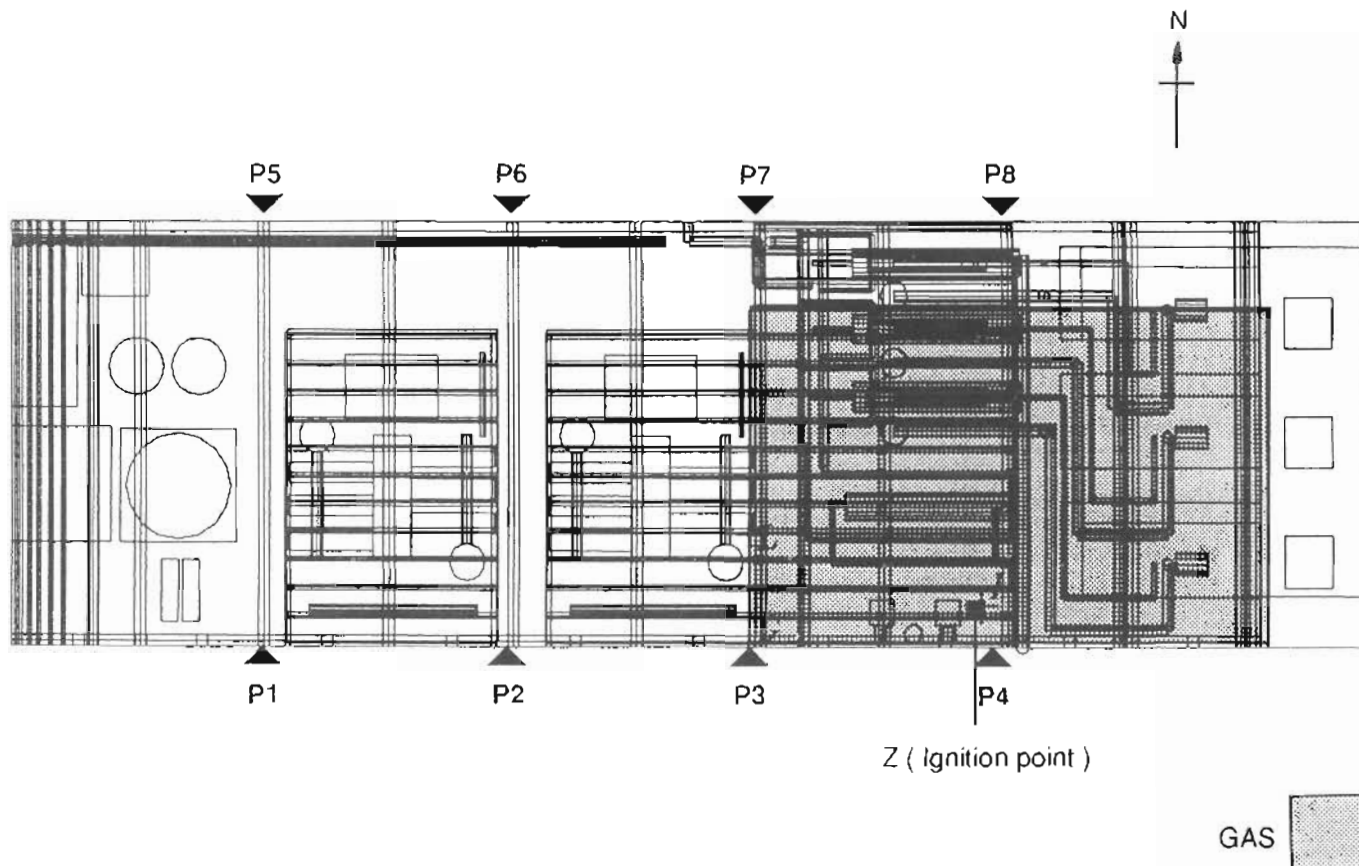
Fig. 6.4 Plan view of C Module showing pressure points P1-P8, 12% fill gas cloud and ignition source Z used in the final CMI explosion simulation.

6.40 The simulation for case 6 showed that the B/C and C/D firewalls would fail along most of their length. However, although the pressures experienced at point 5 are sufficient to cause failure of the north wall at that point, the pressure plots indicated that there was a short section at the west end of that wall which did not see pressures high enough to cause failure. The mass of fuel in the flammable gas cloud in the case 6 simulation was judged by Dr Bakke to be close to the lower limit for a cloud capable of causing substantial failure of the firewalls.

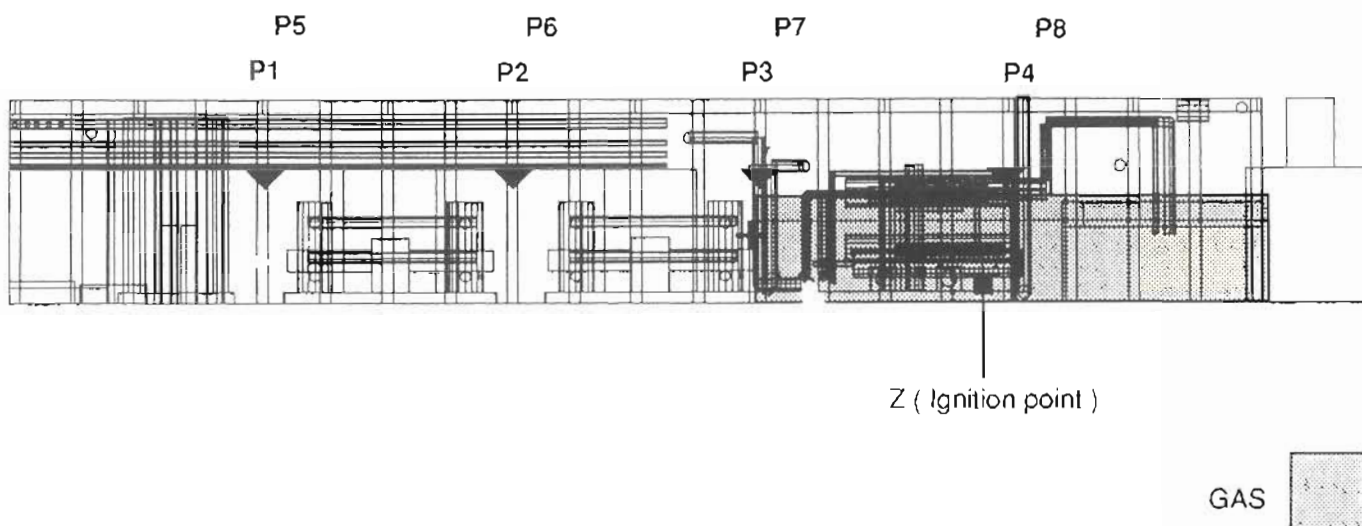
Fig. 6.5 Elevation view of C Module looking north, showing pressure points P1-P8, 12% fill gas cloud and ignition source Z used in the final CMI explosion simulation.

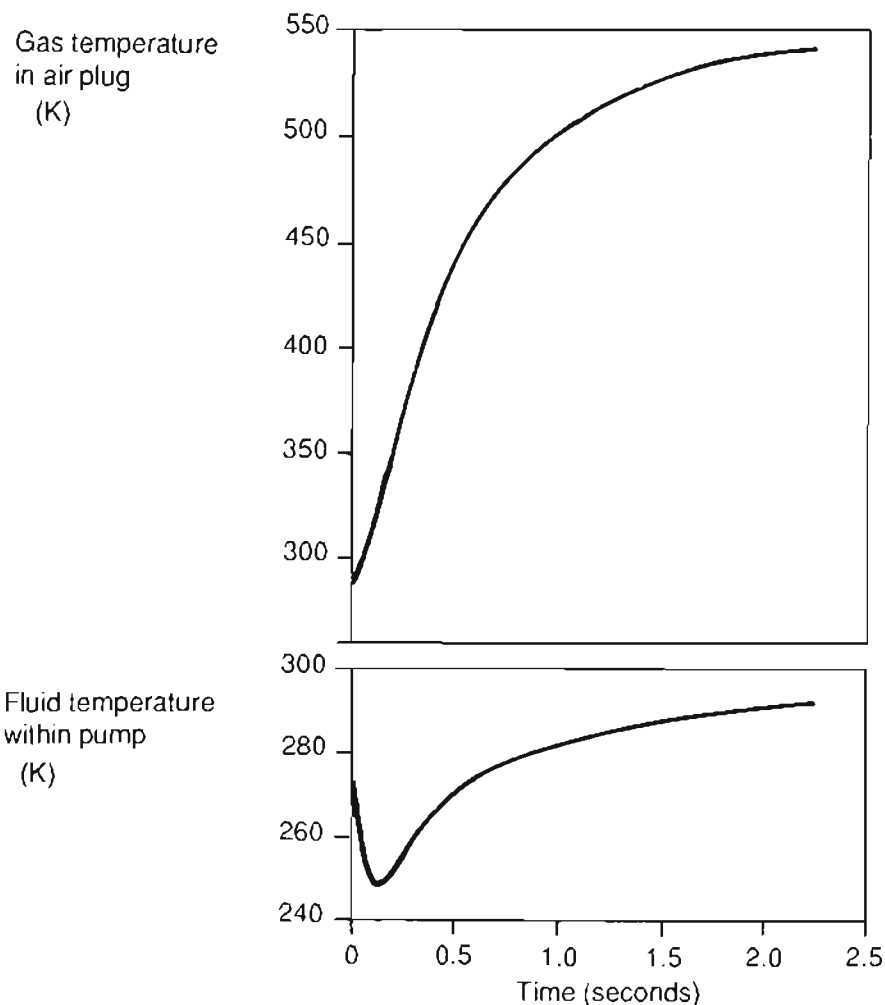
6.133 If a flammable mixture had accumulated in the relief line from the pump, sudden admission of condensate would cause compression of this mixture and could possibly result in ignition. Such autoignition would be similar to that which occurs in a diesel engine, where ignition is effected not by a spark plug but by compression, although the temperatures attained would be much lower. For ignition to occur, there would have to be a flammable mixture in the system. In other words, there would need to be ingress of air, which would depend on the extent of any openings to atmosphere. The evidence was that the flange at PSV 504 had been open for about an hour. There were also other possibilities. For example, if the valve used to vent the pump to flare had been left open, condensate vapour, being denser than air, would continue to stream out of this valve, drawing air in at the top through the flange at the site of PSV 504. It was not known how long the pump vent valve might have been open nor whether this coincided with the period when the flange was open. As far as

Fig. 6.6 Estimated temperatures of gas (air) and liquid on admission of condensate through GOV 5005 into condensate injection pump A system.

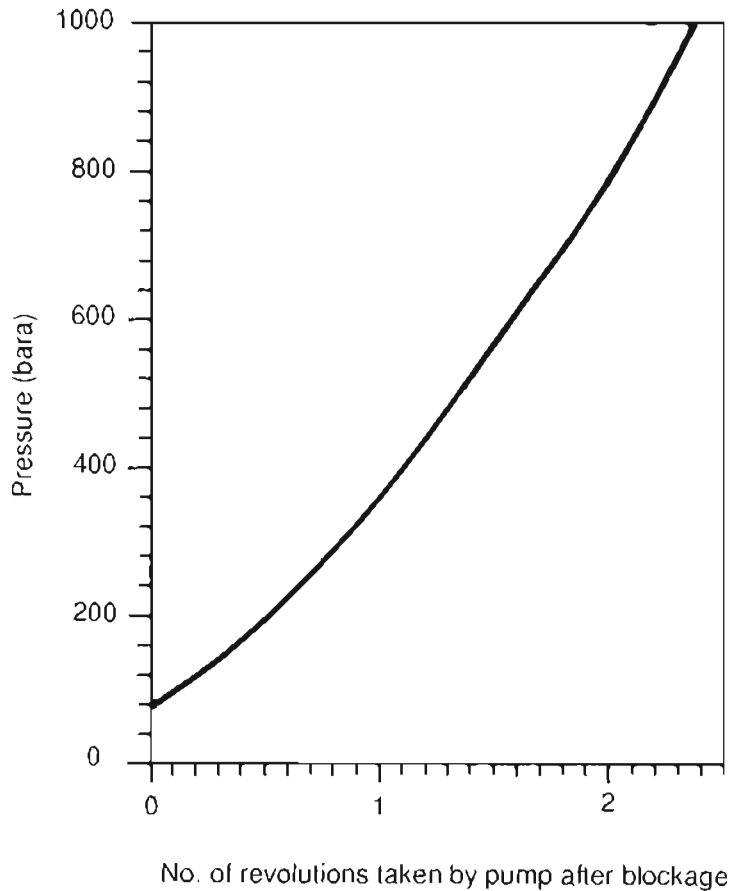
6.158 The pressures which might have been attained if pump over-run occurred were estimated in the ninth report by Drs Richardson and Saville, spoken to by Dr Saville. Fig 6.7 gives the pump discharge pressures as a function of the number of revolutions of the pump and shows that a pressure of 250 bar would have occurred after less than 1 revolution of the pump. At the normal pump speed of 100 rpm, this pressure would have been reached in about 0.6 seconds, or at the minimum speed of 40 rpm in 1.5 seconds. The pressures estimated assume that nothing happens to prevent such pressure rise. Dr Saville mentioned as points to consider whether the pump pistons or valves would withstand the pressures or the drive fracture. He agreed that it would also be necessary for the hydrate plug to hold, but stated that he had experience of plugs of particulate matter withstanding 2000 bar, albeit in different sized pipe.

Fig. 6.7 Estimated pressure rise in condensate injection pump B discharge pressure with no pressure relief.
