Storage tank on Fire

EPSC Learning Sheet - April 2018

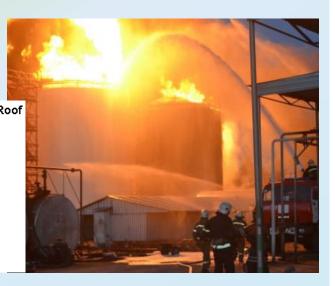
A storage tank with an inner floating roof got on fire while being loaded from a tanker with gasoline.

- ➤ Floating roof of flammable liquid storage tanks are zone 0, that require elimination of all ignition sources
- > Hydrocarbons can accumulate here and need to be vented
- ➤ In this incident, it seems that a spark generated around the floating roof seal started the fire
- ➤ Check seal performance with e.g. an explosion meter or FLIR
- ➤ Assure that the internal floating roof is well bonded
- ➤ Minimise trembling & static charging due to gas bubbles from filling, by inlet pipe design

- ➤ Automatic extinguishment of rim fires is good practice
- ➤ Good design and fire protection needs to avoid domino effects from heat radiation, use QRA and apply safe distances
