Chloride Stress Corrosion

EPSC Learning Sheet , July 2018

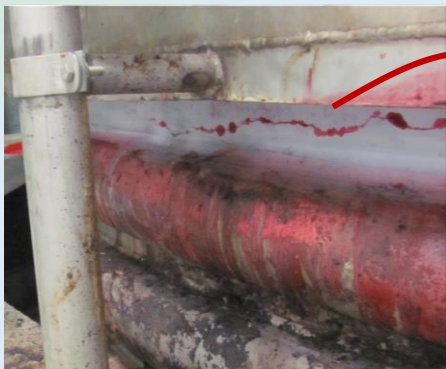
A leak was discovered on a stainless steel pressure vessel, that showed large cracks that started underneath adhesive tape. The cracks grew undetected behind thermal insulation.

Crack in vessel wall
(visible with red die)

Avoid corrosion of Stainless Steel by Chlorides,
here from an unexpected source

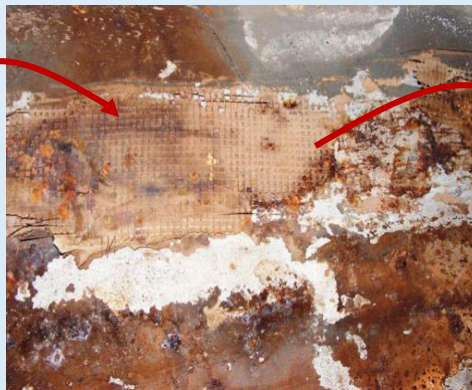
Corrosion developed under
adhesive tape

- Chloride Stress Corrosion Cracking occurs as of ca 50 °C on Stainless Steel (like 304 & 316) in the presence of Cl⁻
- Adhesive tape was found to be the source of the chlorides: 4% Chlorine was detected in the remains of it
- Local repair can be possible, never easy
- Avoid chlorides on stainless steel
- Be aware that glue (e.g. tape), inks marker pens) and sometimes insulation can contain chlorides

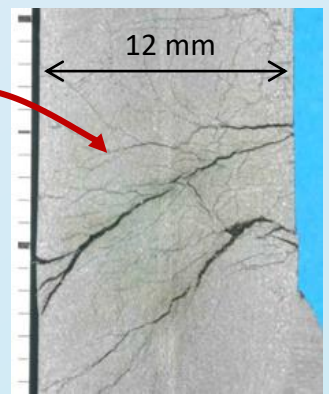
Cracks through wall
