# Explosion of a Reactor

EPSC Learning Sheet Oct 2021

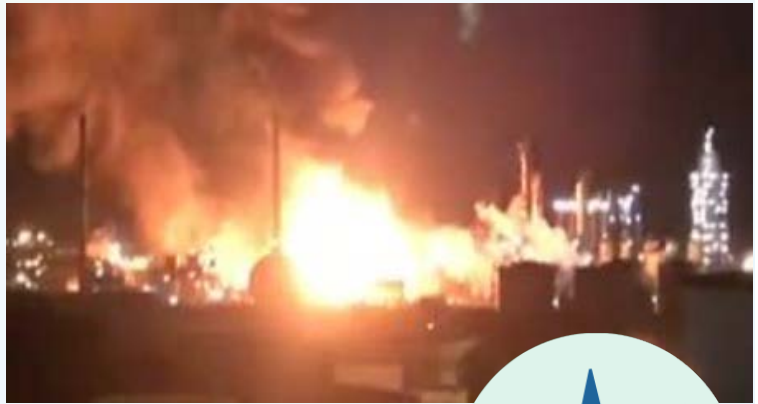
In Tarragona (2020) an Alkoxylation reactor exploded, due to the decomposition of the alkoxylation products and / or the reactant Ethylene Oxide (EO). Two operators died at the site. Debris killed a citizen at 2.5 km.

- Alkoxylation products and EO can decompose violently when the temperature gets too high. With alkaline catalysis this can start below 200 °C. This can result in an explosion.
- Understand the chemicals and decomposition energy & kinetics, also under abnormal conditions.
- Determine the safe distance between reactor and buildings and explosion pressure resistance of the buildings
- The accumulation of free EO in the reactor must be limited, to disable an uncontrollable runaway reaction. Amount of free EO is indicated by the pressure in the reactor.
- Ensure sufficient Reactor cooling and temperature control
- SIL rated interlocks should avoid critical scenario's such as EO accumulation, cooling loss and backflow into the EO line.
- Involve a safety expert on Alkoxylation and EO
