Explosion at Hydrogenation unit

EPSC Learning Sheet December 2022

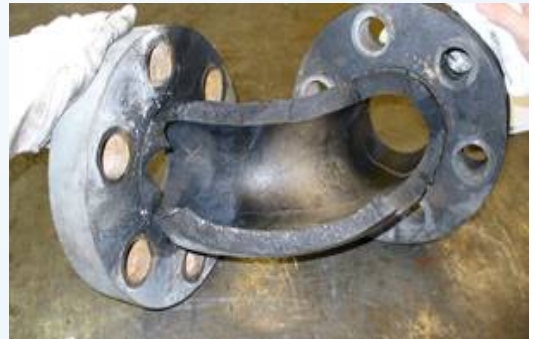
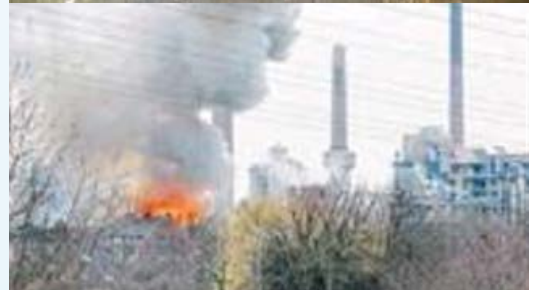
A rupture of an 8" pipe elbow in high pressure (280 bar) and high temperature (320° C) service in a hydrogenation plant was followed by a release and ignition of hydrogen. The construction material of the elbow was carbon steel which is not a resistant alloy and prone to high temperature hydrogen attack (HTHA) at mentioned conditions.

- Hydrogen under high pressure and high temperature will cause hydrogen attack resulting in micro fissuring and decarburization due to methane formation. Suitable material (Cr/Mo alloys) need to be used within their Nelson curves (API-941 ed 8th), checked regularly. Material selection need to be reviewed during revalidation of the hazard assessments.
- Make sure to check the correct material of construction sufficiently during assembly and posterior maintenance. Verify the equipment marks to avoid installing a non-suitable piece of equipment.
- A proper MOC process needs to ensure that all potential risks are checked including material aspects. When replacing components, a “real in-kind replacement” needs to be guaranteed.
- A Pre-Start-up Safety Review with elaborated checklists can assist to unveil deviations in materials of construction.
