# Thermowell Crack

EPSC Learning Sheet November 2023

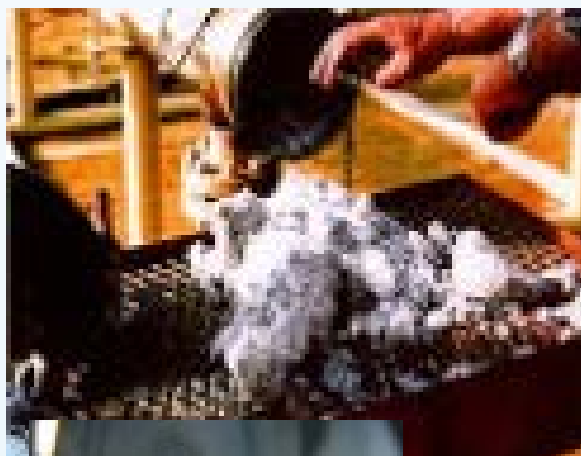
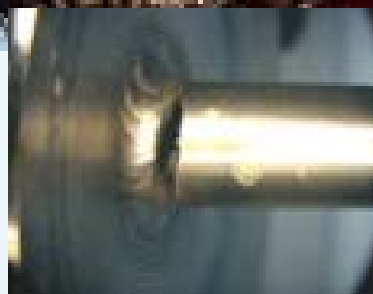
At an off-shore gas plant a leak from a high-pressure pipe occurred at the location of a thermowell, starting a fire in the insulation.

The velocity in a gas cooler heat exchanger was increased, resulting in resonant vibration of the thermowell, causing a fatigue crack.

- Hydrate formation in a cooler, caused a blockage and doubled the gas flow in the parallel cooler.
- High flows around a thermowell caused vibration that resulted in a fatigue failure.
- Small bore tubing (< 1 inch) is sensitive for fatigue cracks. Examples: thermowell in a high flow system, pressure sensor near a compressor, drain near a chattering PSV.
- “Resonance” or “Fatigue” can be useful guideword in a HAZOP or design review
- Fixation and Gussets can help to strengthen design

**Prevent Resonant Fatigue Failures**
