Natural gas pipeline rupture

EPSC Learning Sheet February 2025

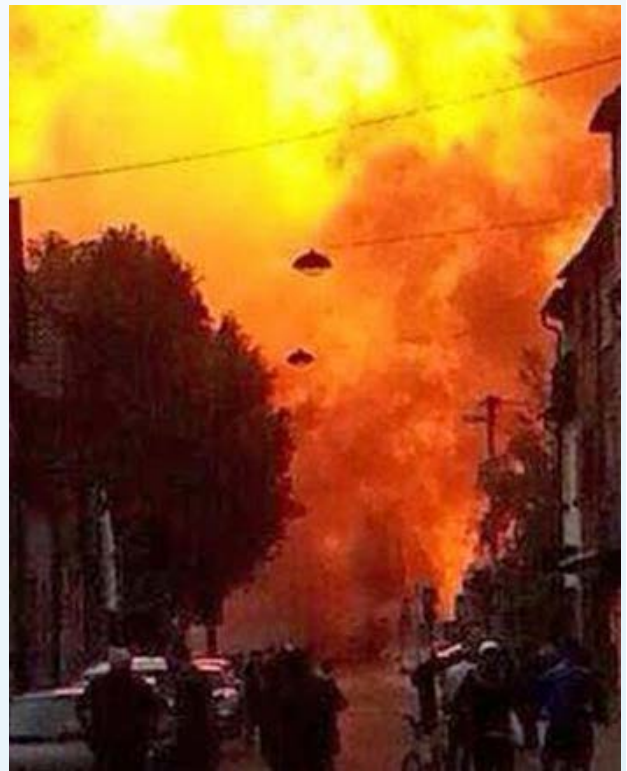
During the dig out of an 80 bar natural gas pipeline for repair, a corrugated steel plate was driven into the pipeline, which then ruptured (Oppau Germany 2014). The released gas exploded and a huge jet fire in a populated area resulted in two fatalities and damages to surroundings.

- Heat radiation damaged buildings and cars in a 200 m radius
- Perform a hazard and risk assessment before starting ground work. Use specific permit to work forms, for approval.
- Know the exact position of underground pipelines before starting ground work. Do not trust maps. Validate the precise location in the field.
- Use of non-aggressive techniques for excavation, like working with hand tools or vacuum cleaners.
- Minimize personnel at the digging location.
