Morandi Bridge Collapse

EPSC Learning Sheet December 2024

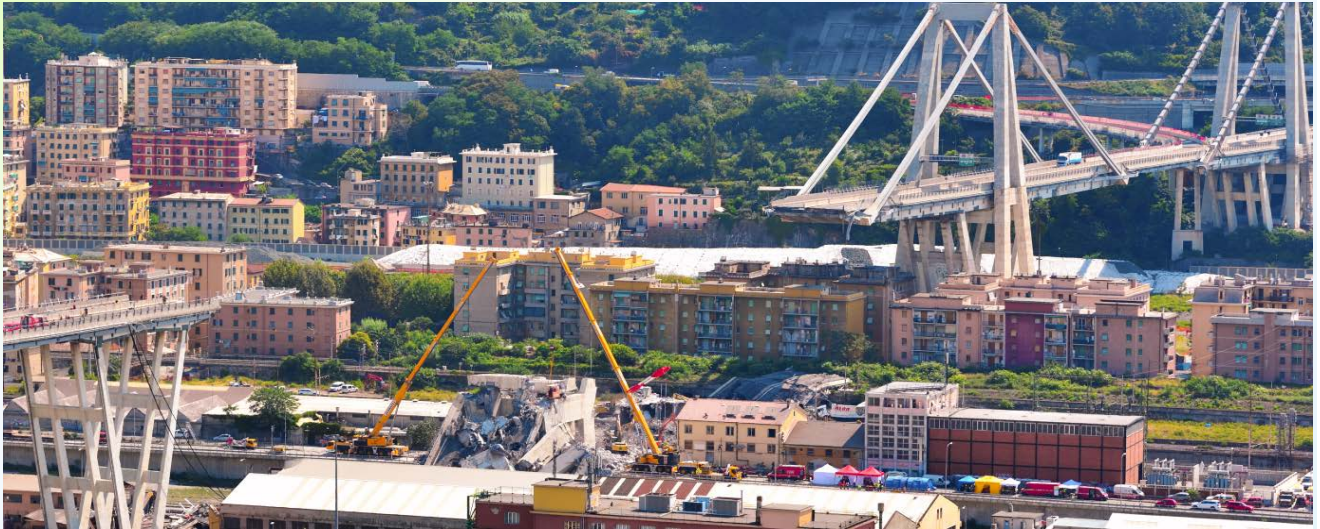
On 14 August 2018, during a rainstorm, a span of the 1182 m long and 45 m high Morandi bridge in Genoa broke. The bridge collapse caused 43 deaths.

- The 90 m high concrete pillars with diagonal cable stays were holding a 200 m wide span.
- Internal inspection of the metal inside the prestressed concrete pillars (from 1967) was difficult. In 1990 only pillar 11 was inspected, showing that 30% of the tendons (iron bundled wires) had corroded away, potentially enhanced by ingress of Chlorides from the sea.
- Unnoticed deterioration of mechanical parts in critical equipment is a well-known reason for incidents also in the chemical industry. When designing and accepting such equipment, inspection should be considered.

Assure during design that inspection of all critical parts, is quite possible
