The Public Inquiry into the Piper Alpha Disaster

The Hon Lord Cullen

VOLUME ONE

Presented to Parliament
by the Secretary of State for Energy
by Command of Her Majesty
November 1990

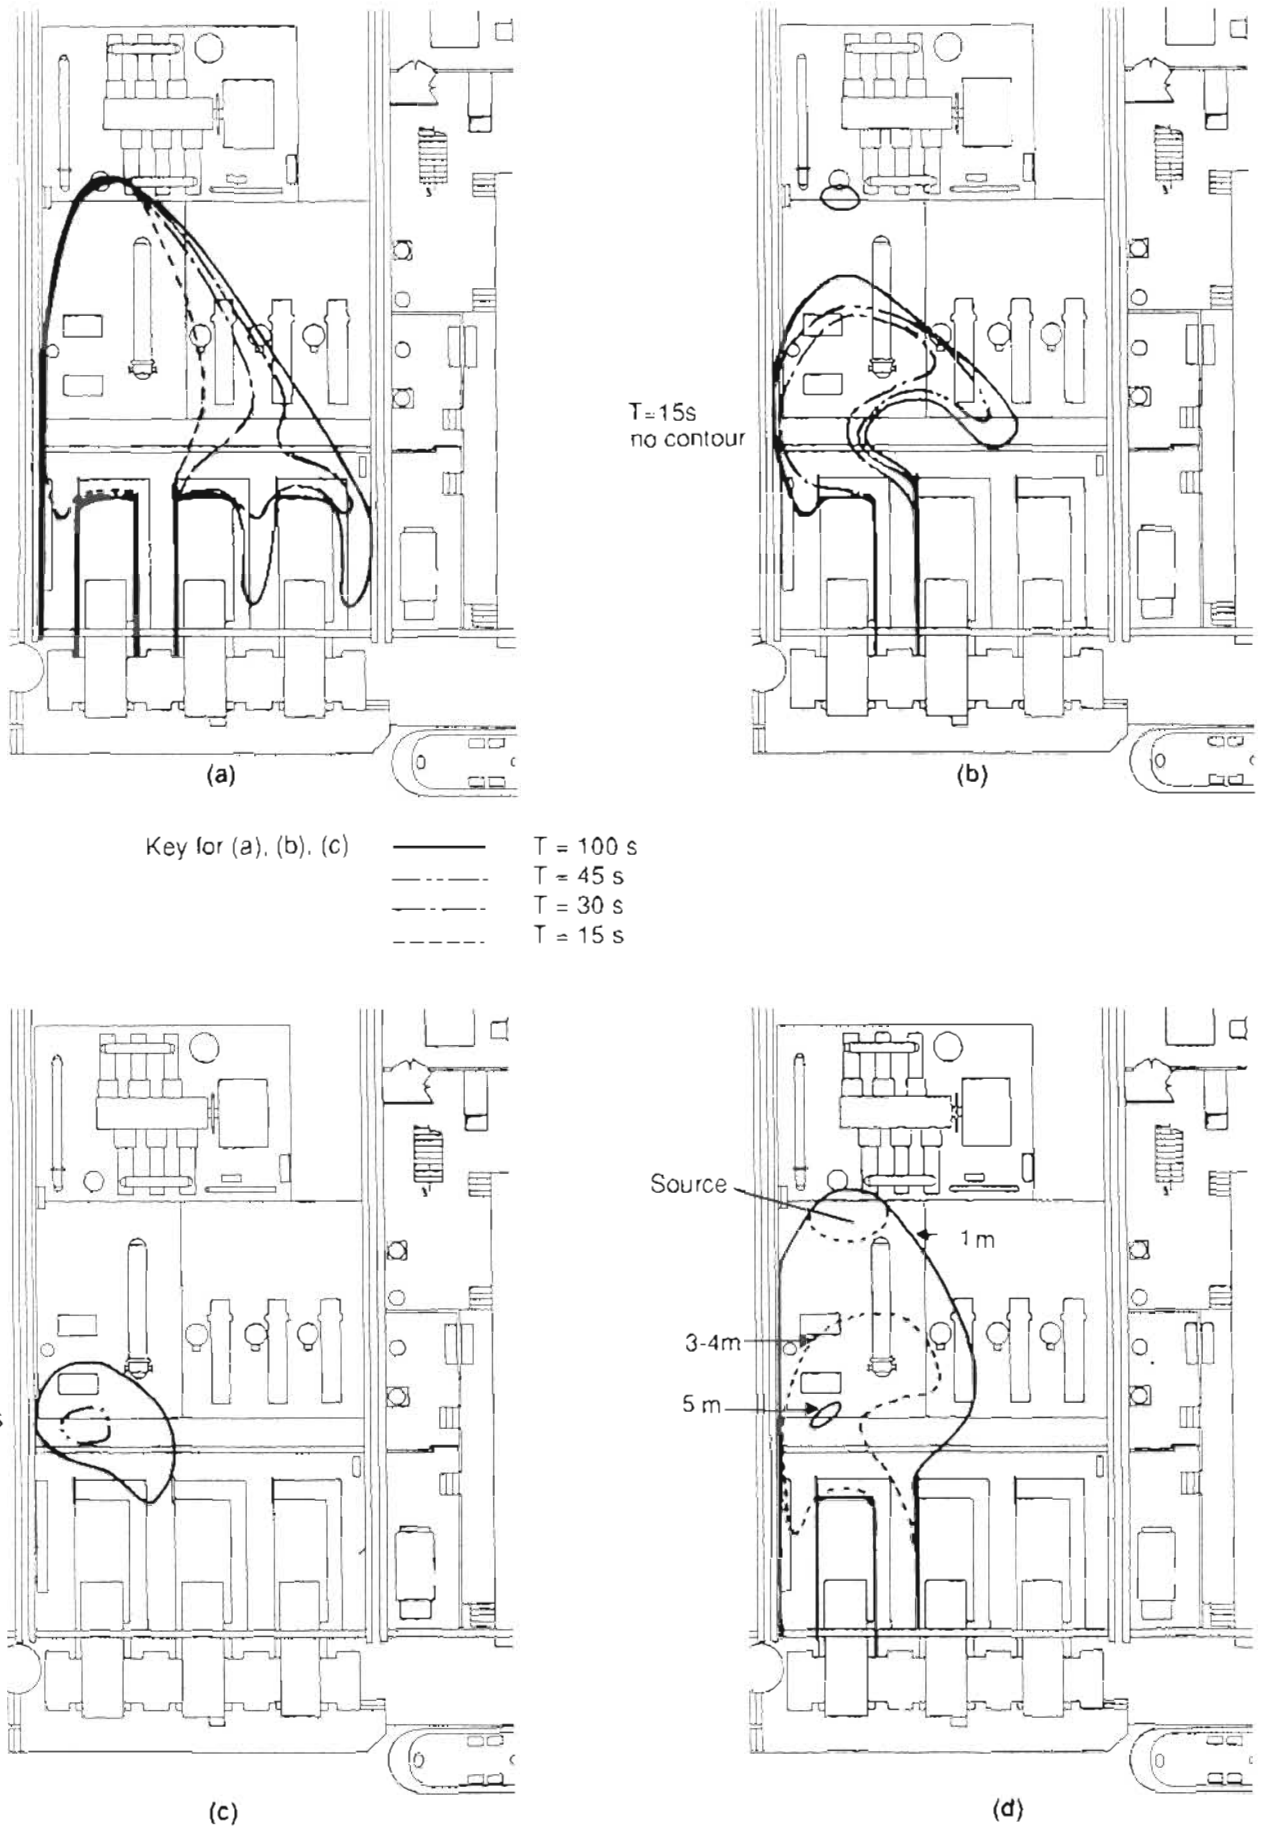
6.29 The detailed development of the flammable gas cloud for the 100 kg/min leak in series 42 is shown in Fig 6.1. Figs 6.1(a)-(c) give the contours of the LEL of the cloud at low, medium and high levels, respectively, at times 15, 30, 45 and 100 seconds and Fig 6.1(d) the LEL contours at different heights at 30 seconds. The floor level LEL contour at 100 seconds was close to the final steady-state contour. Information on the mass of fuel within the flammable part of the cloud for different leak rates was presented in 2 ways. Fig 6.2 shows the growth of the mass of fuel, both total mass and mass within the flammable region, as a function of time for series 15, 42 and 45. For the first 2 cases a steady state is reached after about 100 seconds, and for the third after about 140 seconds. For the 100 kg/min leak of series 42 the mass within the flammable region is some 30 kg at 30 seconds, 40 kg at 60 seconds and 45 kg at steady-state at about 100 seconds. Fig 6.3 shows the effect of increasing leak rate on the mass of fuel within the flammable limits, based on series 15 and 42. The graph shows that after 30 seconds as the leak rate increases the mass of fuel reaches 30 kg at a leak rate of 100 kg/min, 45 kg at a leak rate of 110 kg/min and thereafter rises rapidly and that at steady-state the mass of fuel reaches 30 kg at 85 kg/min, 45 kg at 100 kg/min and thereafter rises rapidly.

Fig. 6.1 Growth of the flammable gas cloud for leak of 100 kg/min (Series 42) in the BMT wind tunnel tests: (a) LEL contours at low level ($< 1.7\text{m}$); (b) LEL contours at intermediate level (ca. 3.5m); (c) LEL contours at high level (ca. 5.5m); and (d) LEL contours at 30 seconds.

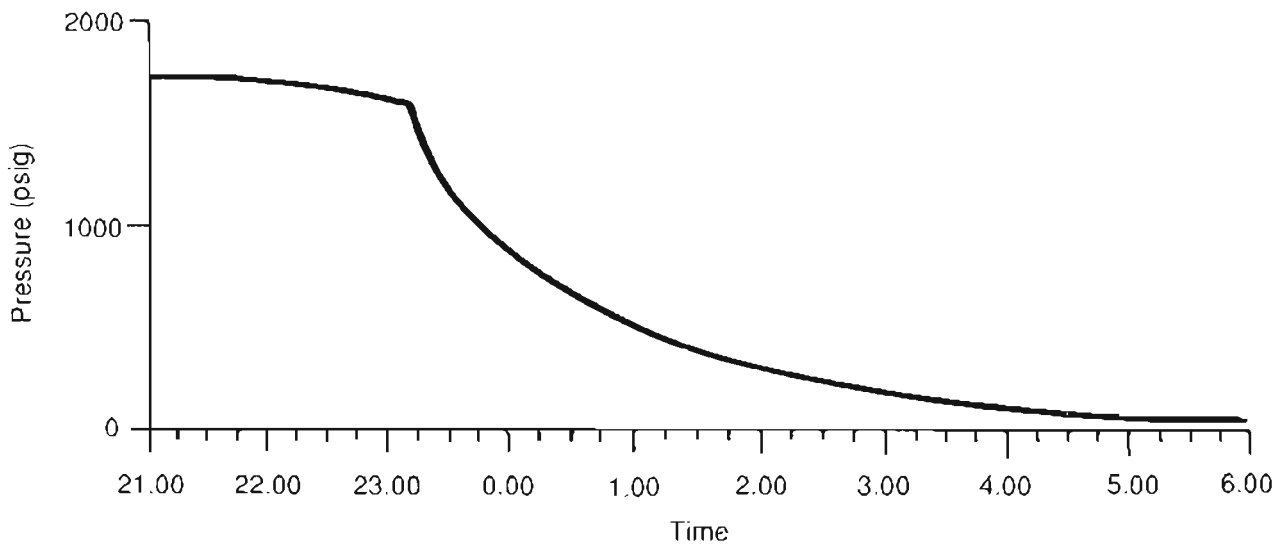
7.36 The depressurisation of the gas pipeline from Tartan to Piper was instructed on Tartan between 22.30 and 22.45 hours. This took until 23.20 hours to set up, the last step being the opening of the export gas valve ECV 54. As will be explained below, it was then found that the pipeline contained virtually no gas pressure which was capable of being measured at Tartan. The depressurisation of the gas pipeline from Piper to MCP-01 was carried out at MCP-01 starting just after 23.00 hours. This pipeline normally contained about 60 MMSCF. The flaring capacity at MCP-01 was 2.6 MMSCFD. The depressurisation of the gas pipeline between Piper and Claymore was instructed on Claymore about 23.00 hours and took about 5 minutes to set up. Depressurisation was carried out through FCV 970. In addition after 24.00 hours gas was taken through the separators to the low pressure flare. It is uncertain how quickly this pipeline lost pressure. According to Mr J Davidson, Operating Superintendent on Claymore, a pressure of 400 psi was reached in about 4 hours, whereas the trend record for this line given in the Petrie Report, which was based apparently on readings taken on Claymore, showed that this pressure was reached after about 45 minutes. The pressure records for all 3 gas pipelines are given in Figs 9.1, 9.3 and 9.5 of the Petrie Report and are here reproduced in Figs 7.1-3.

Fig. 7.2 Trend record of the MCP-01 gas import pipeline pressure on 6/7 July.
