Collapsed Railway Car

EPSC Learning Sheet , December 2018

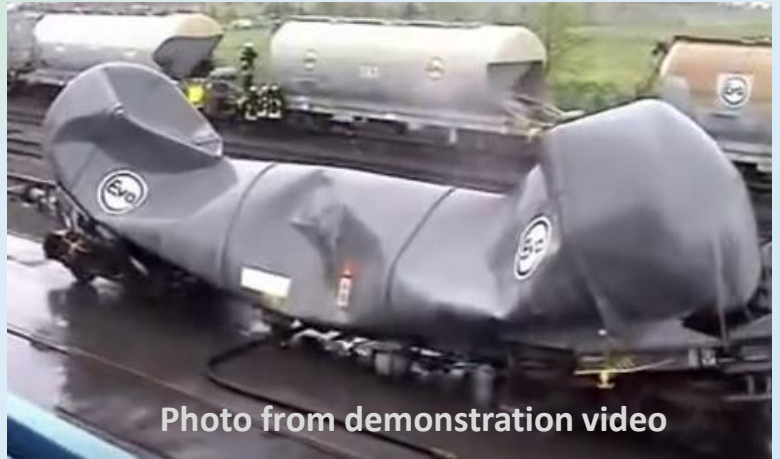
A railway car collapsed during unloading. A new railcar was purchased that did not have the low pressure specification that operation was used to.

Photo from demonstration video

- Emptying without a vapour line results in under-pressure. Railcars (and trucks) often do not have vacuum relief devices. Tanks that are not designed for vacuum will collapse
- When purchasing new equipment, the specifications (like pressure rating) need to be carefully checked
- A connected railcar is part of the process that has to be reviewed in a PHA: include this in the HAZOP
- Use gas displacement procedure, e.g. a vapour line for pressure equalization, when a railcar is unloaded, to avoid low pressure
- Blocked lines (freezing / fouling) may prevent addition of air, nitrogen or vapours and generate unexpected vacuum
- Upon arrival of new equipment, validate specifications before putting it in use, or connecting it to the plant

Assure good specifications for new equipment
