Explosion while hydrotesting a tank

EPSC Learning Sheet September 2024

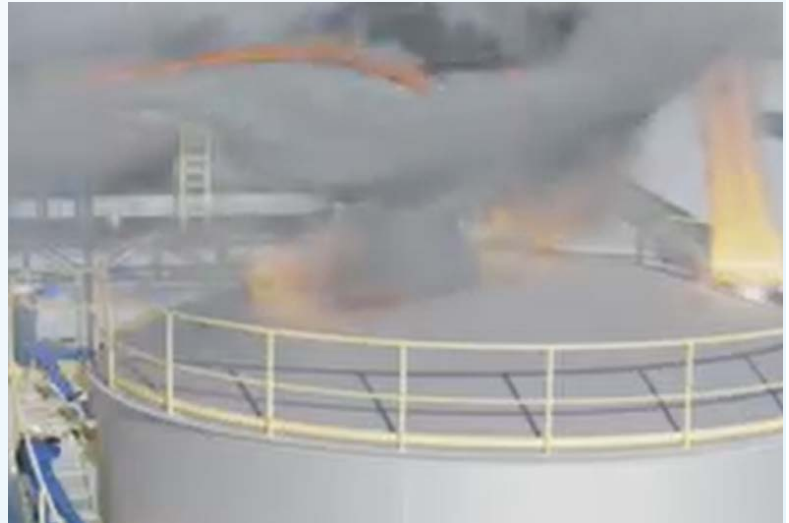
An explosion occurred in a storage tank, during hydrotesting. Two operators that were working on the tank were injured.

- Hydrotesting of a tank is done with water to validate tank integrity: strong and leak free. Here the water was polluted with a flammable liquid that came from the pipelines. It formed an explosive mixture in the tank that was ignited.
- Remove people away from equipment when doing integrity testing. It is potentially dangerous when equipment fails.
- When using hydrocarbon lines to transfer water, they need to be flushed first and proven to be clean.
- This is an Ex zone. The workers might have caused the ignition.
- Equipment integrity testing requires a specific plan, based on a hazard analysis.

Equipment integrity testing needs specific attention
